DAM SAFETY INSPECTION REPORT

**TROWBRIDGE DAM
ID #00604
SW 1/4 SEC 12. T1N, R13W
KALAMAZOO RIVER
ALLEGAN COUNTY**

INSPECTION DATE: April 16, 2004

REPORT DATE: July 12, 2004

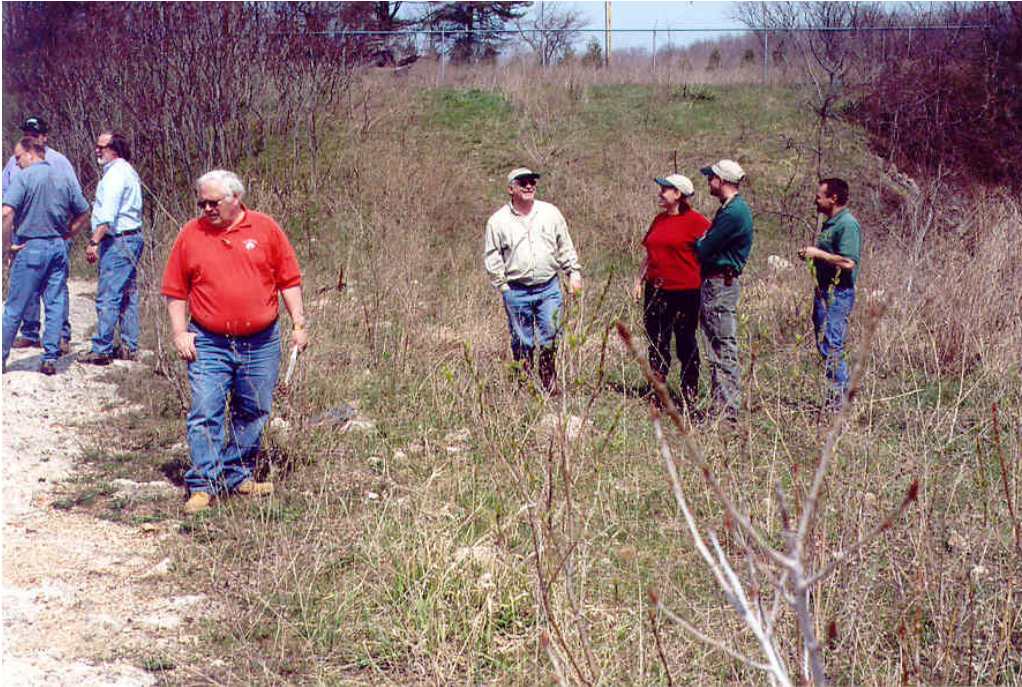
Crest of Right Embankment

- In general, the right embankment is uneven with a low area at the former powerhouse with demolition debris covering most of the embankment. The upstream edge is highly uneven with water forming pools in the debris as much as 15 feet into the embankment. A sinkhole/seepage path was seen on a former visit. Dye testing confirmed that it exited from below the right training wall foundation.

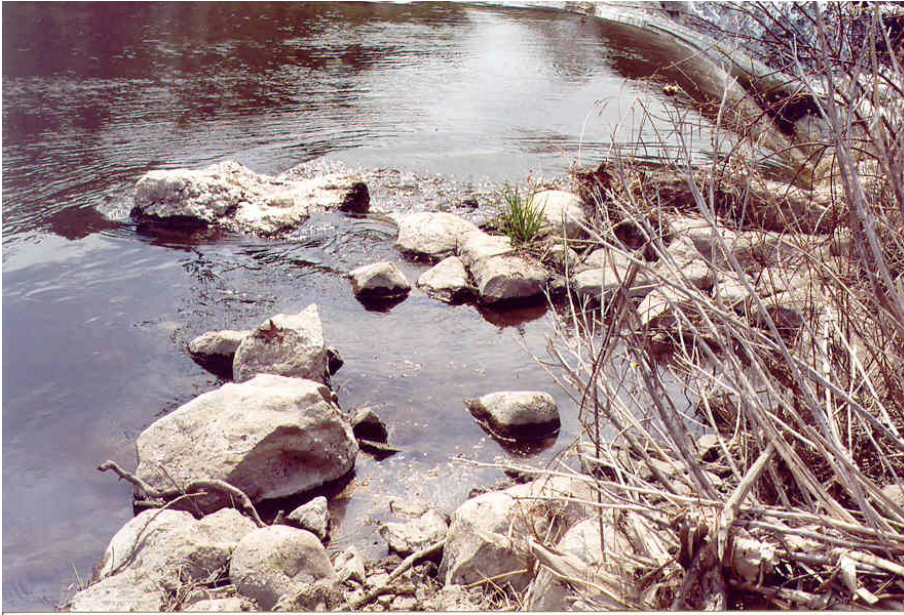
- Upstream portions of the right training wall are missing, causing water flow to move rapidly across the embankment on the right side.
- Upstream portions of the left training wall are missing, causing an area of the left upstream embankment to slough into the river.

Missing Wingwall and Lateral Flow at Upstream Face of Right Embankment

- Reconstruct the downstream portion of the spillway including the entire downstream apron which has broken off. Repair and underpin or entirely replace the spillway as required to provide adequate foundation support, patch deteriorated concrete and fix the hole recently created in the spillway ogee section. Replace missing sections of training wall upstream of spillway to avoid erosion of embankment.

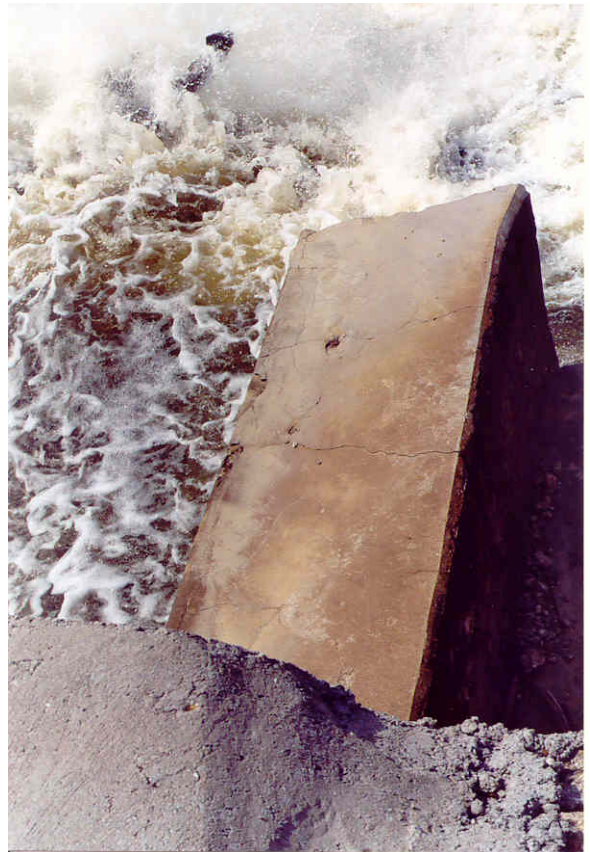
- Downstream areas of apron and training walls are broken off and missing. The large void which formed at toe of dam is filled with boulder fill as an energy dissipater. Boulder fill appears to be remaining in place.

Cracks in Broken Downstream Right Training Wall

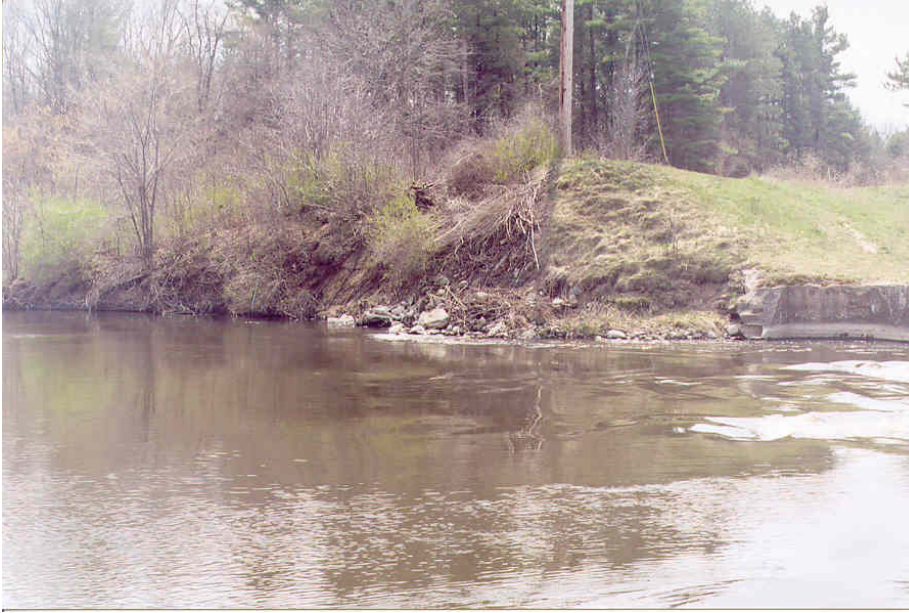
The dam embankments appear to be generally stable with no signs of displacement other than the sloughing where the training wall is missing as the left embankment. However, the area of the former powerhouse does overtop during storm events and while no significant erosion is currently visible, long term exposure to this event could cause instability of the embankment.

View of Sloughing Soil and Erosion at Missing Left Upstream Training Wall

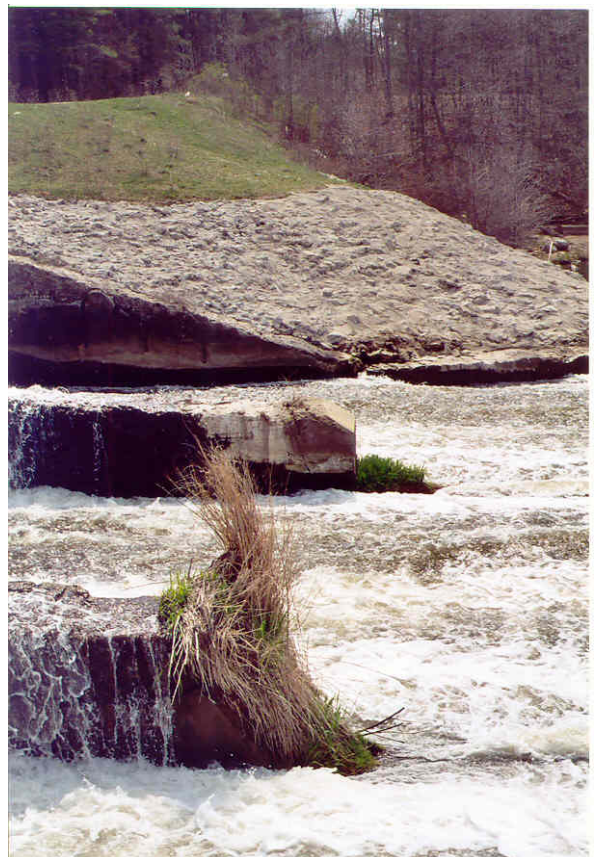
View of Grouted Riprap and Broken Downstream Left Training Wall

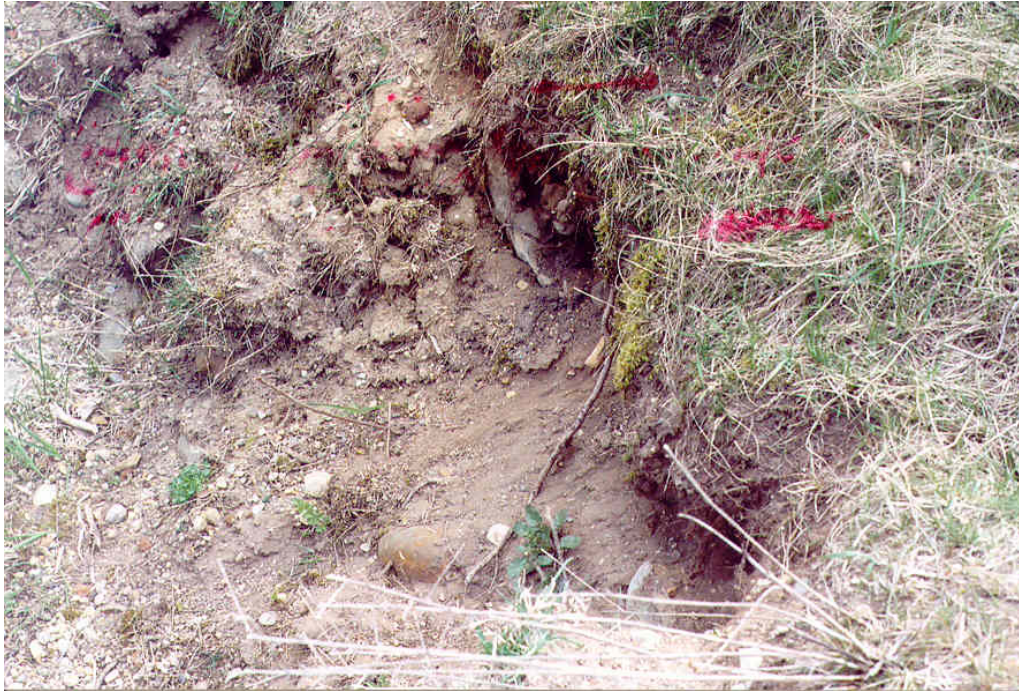
- The missing training wall and low area of the embankment appears to allow overtopping behind the left training wall. Overtopping and/or surface water runoff are causing an erosion path in the upstream area and causing loss of topsoil from around the grouted riprap on the downstream side of the embankment.

- Erosion paths on upstream left embankment and downstream right embankment.
- Missing stones from toe of grouted riprap where grout penetration was inadequate.

Erosion on Upstream Left Bank

- Fill all erosion paths on the upstream and downstream areas of the embankment and abutments and vegetate with grasses.
- Fill around edges of grouted riprap and patch or seal cracks in riprap surface. Provide additional riprap at downstream edge of grouted riprap to avoid further loss of riprap.

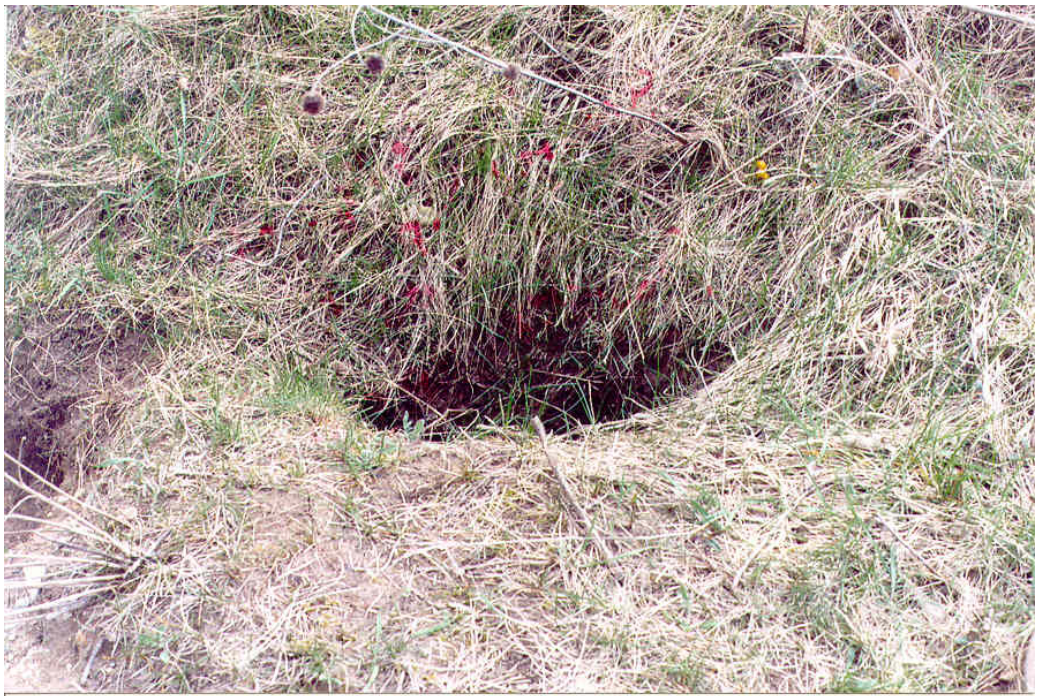
Animal Burrow on Downstream Face of Left Embankment

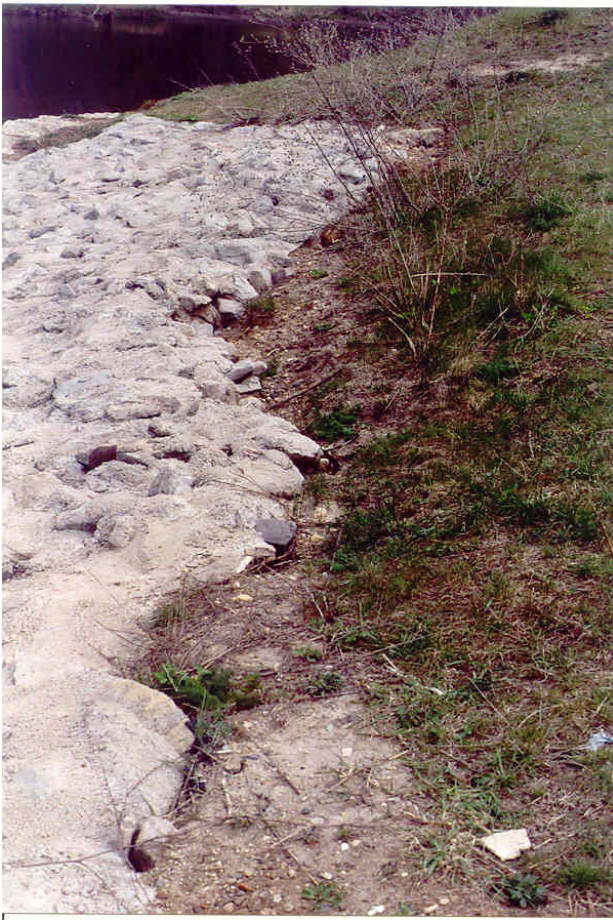
Erosion along Edge of Grouted Riprap

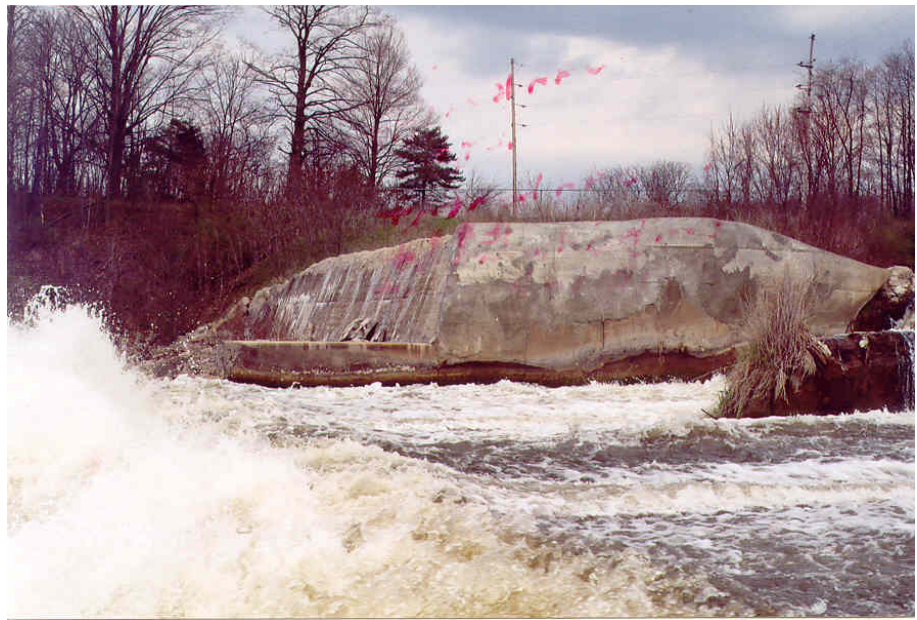
Repaired Right Training Wall

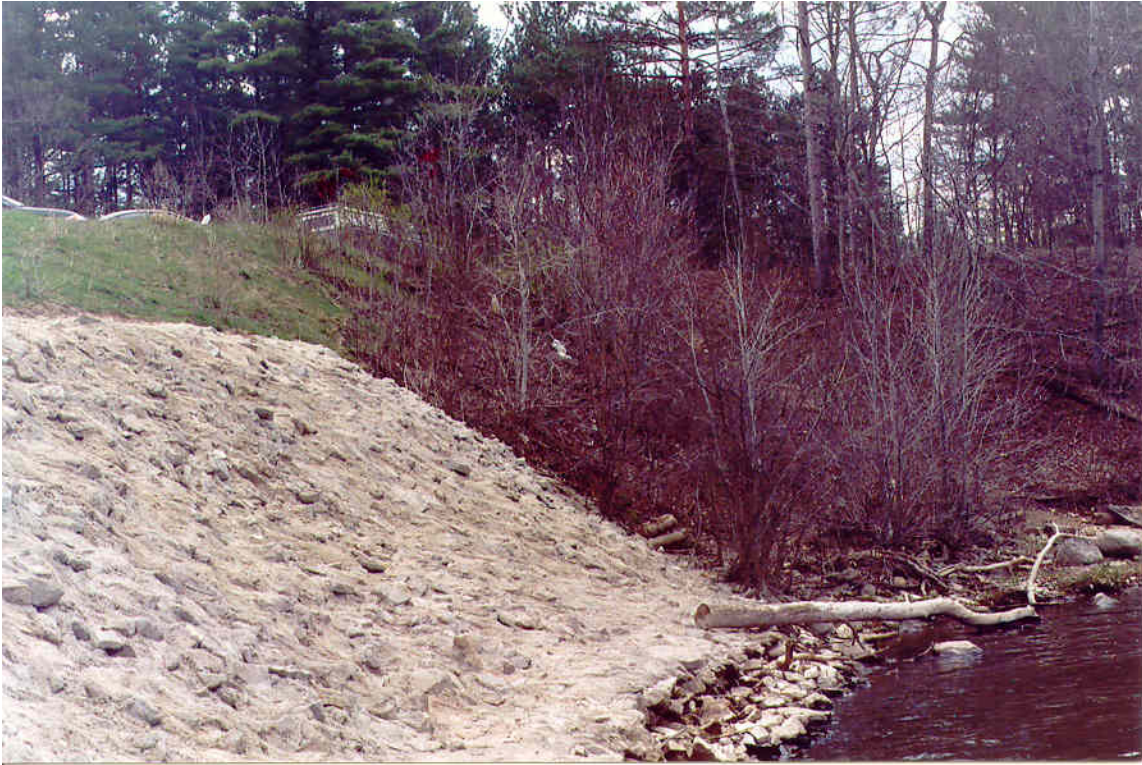
- Brush and trees are present on the upstream and downstream areas of each embankment. No upstream erosion protection is present. In addition, areas of the left downstream embankment slope, where in contact with backwater pool, also require erosion protection.

Brush on Downstream Slope of Left Embankment

- The entire left and right embankments should be re-graded, removing all trees and brush, and shaped with an even crest with upstream and downstream slopes no steeper than 3 horizontal to 1 vertical. The upstream slope of the re-graded spillway should be protected by riprap with grass planted over the remainder of the spillway. Additional slope protection should be provided on the downstream slopes in the range of potential backwater levels against the dam.
